A Proposed Repair Plan for the Pelican Boardwalk

Alaska Department of Transportation
and Public Facilities
Southeast Region Design and Engineering
PO Box 112506
6860 Glacier Highway
Juneau, AK 99801-2506

OCTOBER 2006

BOWEN ENGINEERING
4511 Chelsea Ct
Juneau, AK 99801-7309

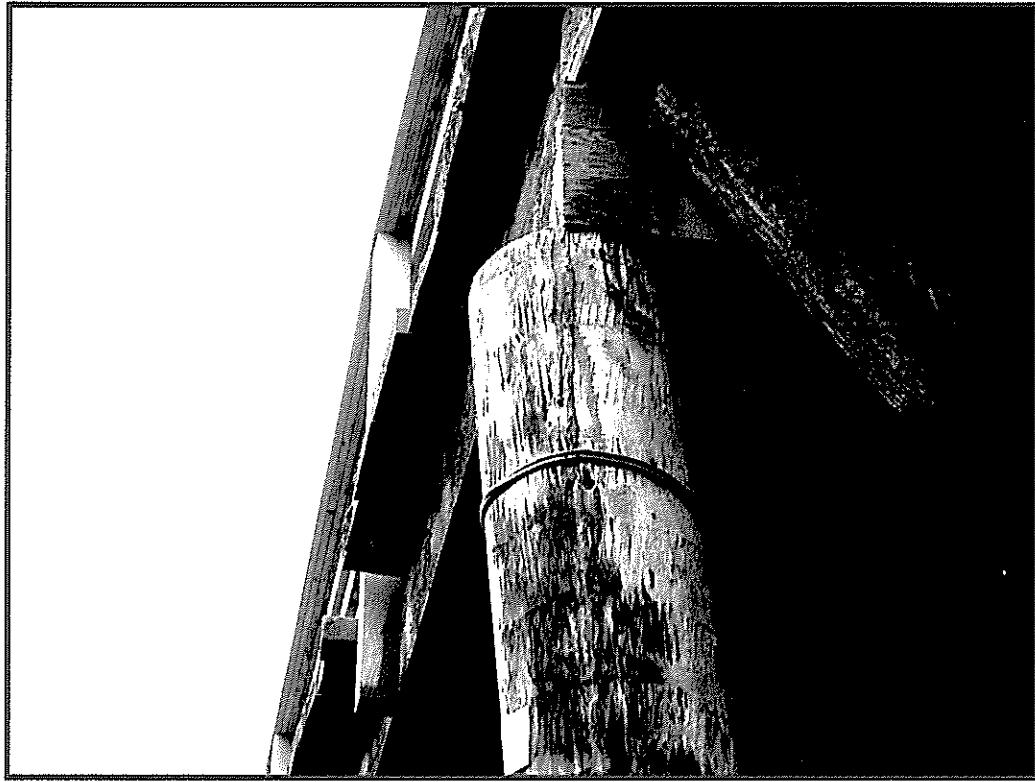
This is the outboard pile at location #86. Note the sawn brace and the partial pile cap support.

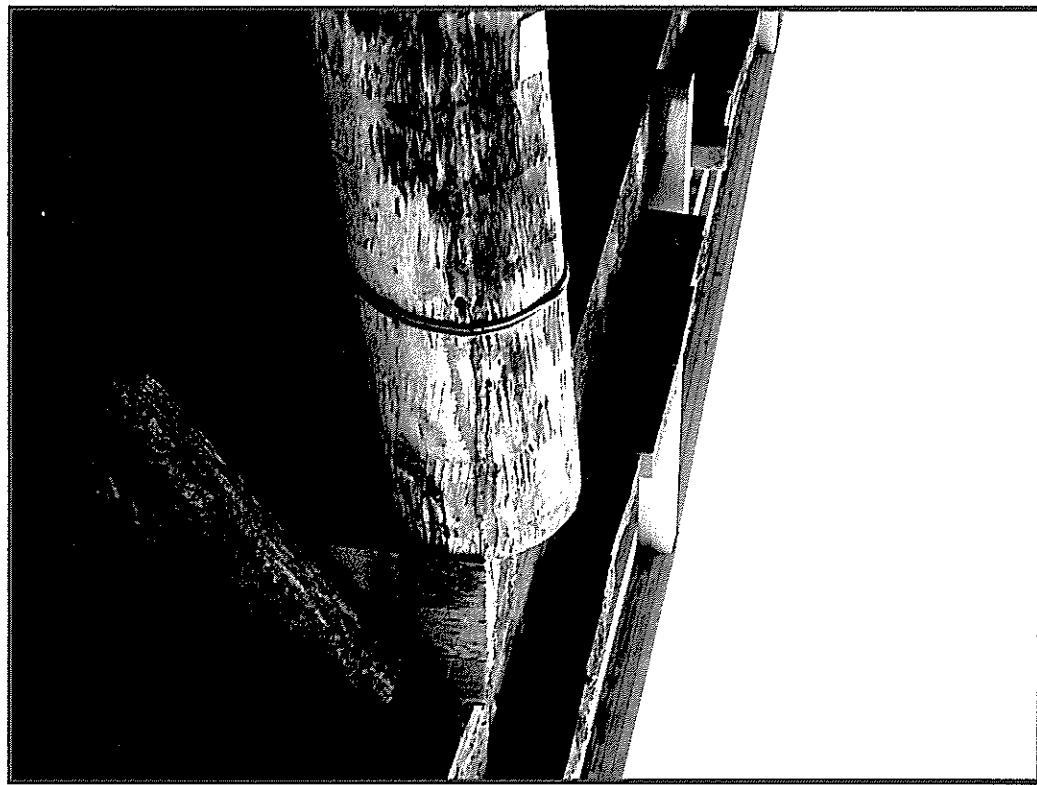
support:

This is the outboard pile at location #86. Note the sawn brace and the partial pile cap

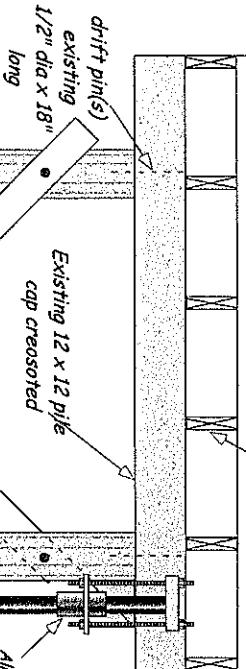
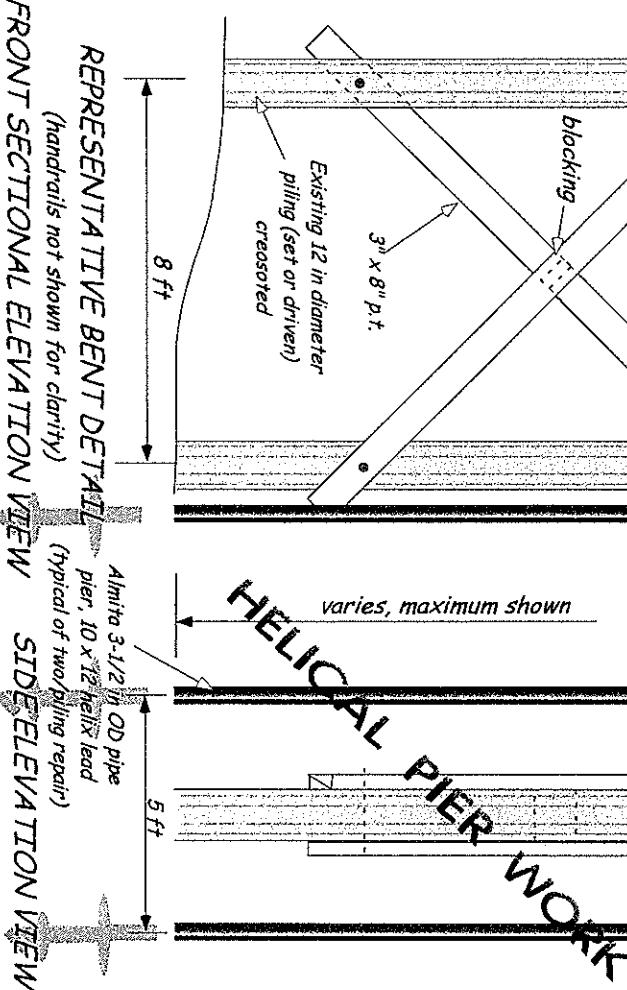
Figure 1: Piling and Piling Cap Repair

(9) Identified positions from the 2003 boardwalk inspection for piling replacement are pier #: 21 (left); 59 (left); 60 (left); 68 (left); 69 (left); 86 (right); 137 (seaward); 142 (seaward); 158 (seaward); 175 (left); 177 (right); 179 (left); 186 (left); 188 (seaward); 189 (right); 197 (right, left); L67 (right, left). Note that additional piling replacement may be required since the 2003 inspection. Total number piling replacement this item: 19.

(10) Identified positions from the 2003 boardwalk inspection for pile cap replacement are pier #: 27, 48, 88, 90, 93, 96, 146, L43, L46, L50. Note that additional pile cap replacement might be required since the 2003 inspection. Total number of pile caps to be replaced 11 this item. Extra wood allowed for blocking and pile caps as contingency planning.

Figure 1 indicates a proposed piling and/or pile cap repair. Helical piers are utilized. The pier installation requires the width of a Bobcat (about 6 ft with a blade on it). Only one decking plank at a time requires removal for a helical pier so a steel plate or sheets of plywood can be placed on the other side during construction.

(1) Two 3-1/2 inch OD pipe piers with 10" x 12" helix lead sections required per piling.

(3) If upper portion of existing piling is so rotten or otherwise deteriorated that existing brace is no use set new 3" x 8" p.t. brace to pile cap. If base of piling is too deteriorated to accept wooden brace, set tieback per Figure 2. Almita tension clamps are tied to pier. For purposes of estimating costs and quantities assume worst case. If pile cap is also deteriorated, attach to new blocking. Attachment is by nailed cleats to new blocking (not shown).

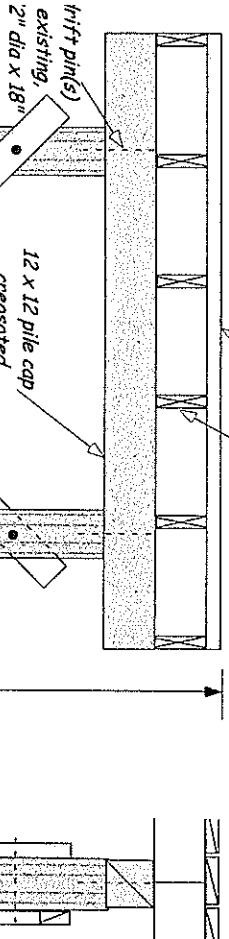
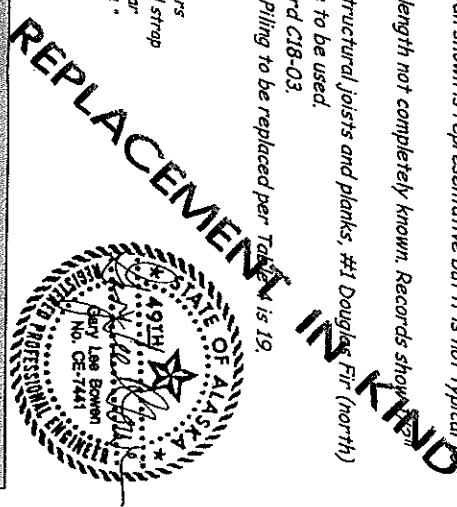
Figure 4: Piling/Pile Cap Replacement

- (1) Bent details vary along the boardwalk. Detail shown is representative but it is not typical all bents.
 (2) Existing drift pin type, size, number, and length not completely known. Records show 18" diameter by 18" long were purchased.
 (3) All replacement wood to be suitable for structural joists and planks, #1 Douglas Fir (north) or better. No #2, #3, or economy grades are to be used.
 (4) Replacement wood to meet AWPA Standard C18-03.
 (5) Pile caps to be replaced per Table 4 is 11. Piling to be replaced per Table 4 is 19.

Figure 4 shows piling and pile cap replacement based upon replacement in kind. This is inter-tidal work that will impact the boardwalk use during construction. For a pile cap replacement, boardwalk access will certainly be an issue. There is also a contingency impact by removing existing decking, stingers, and railings.

- (1) Replacement 12" x 12" pile cap, minimum length 14 ft, p.t. #1 Douglas Fir (north) or better, trim to fit.
 (2) Remove decking, handrail and stringers from spans each side. Cut existing pile to pile cap drift pins with reciprocating saw (wedge up pile cap with steel wedges for blade clearance).
 (3) Place new pile cap with new 5/8" x 18" drift pins, pre-drilled. Reinstate stringers, deck, and handrail as required.

- (1) Shore boardwalk, limit traffic to foot traffic only, remove cross braces at subject piling.
 (2) Chain saw out the existing piling and remove debris to City of Pelican approved site.
 (3) Dig out for a 2-1/2 ft x 2-1/2 ft x 9 inch thick precast footing. Place the footing at a similar depth to the existing footing or deeper. If the piling to be replaced is driven, place the footing on top of the cut off piling at a depth of 2 ft below the ground surface.
 (4) Set piling on footing and attach, trim, wedge and drift pin to the piling cap.
 (5) Remove shoring, replace cross braces.

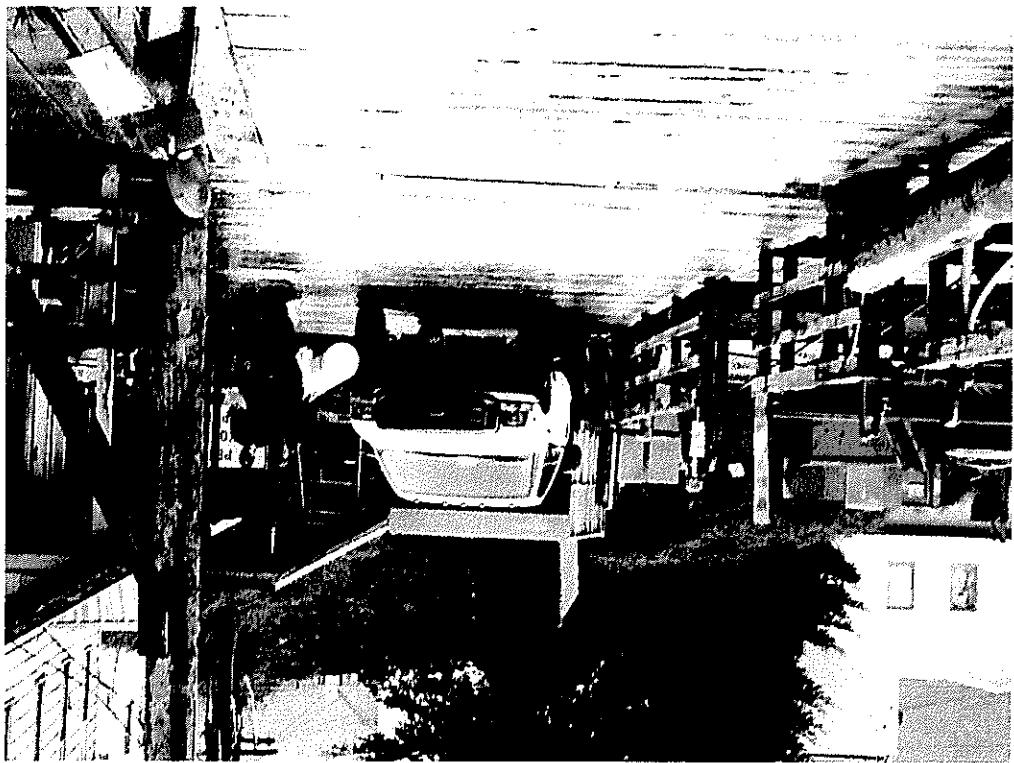
Above: 1984 GMC 7000 diesel fire truck parked in the City garage (design vehicle).
Below: Garbage truck working
